TEST REPORT

OBJECTIVE: To determine the efficacy of a scanner intended to detect the presence of hidden electric motors in carbon bicycles.

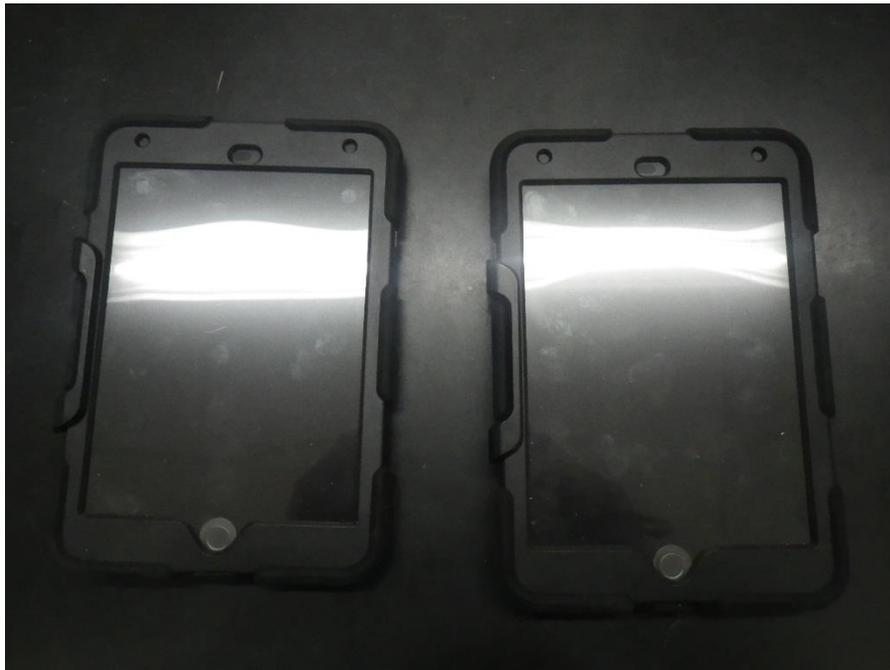
Figure 1: UCI Scanners

SAMPLES: Two (2) UCI iPads, equipped with a custom electric motor detection sensor and applicable software, arrived at Microbac Laboratories on February 9, 2017. The iPads are referred henceforth as the UCI Scanners, and are shown in Figures 1 and 2. The sensor on each Scanner, as previously described herein, is designed to detect the presence of and disturbances in a magnetic field, created by electric motors.

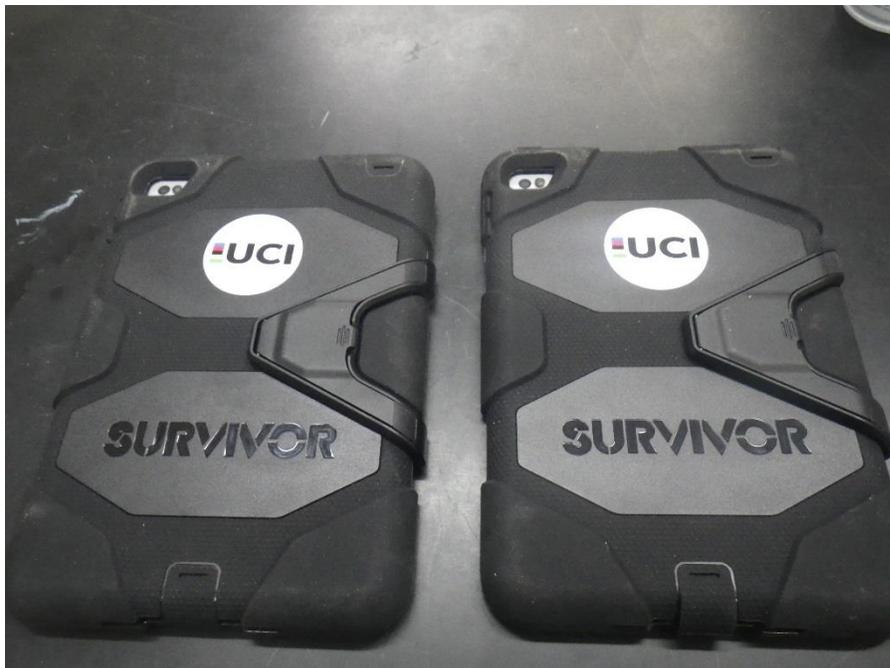
Figure 2: UCI Scanners

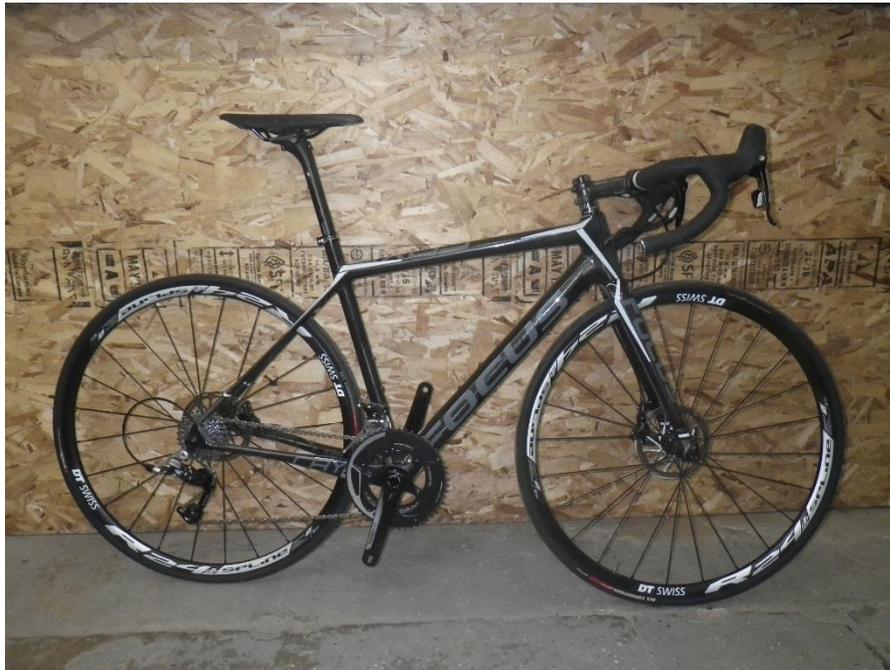
Figure 3: Focus Cayo carbon, small size, SRAM Rival mechanical drivetrain.

Four (4) bicycles of carbon fiber construction arrived at Microbac Laboratories for testing on various dates in March 2017. Two of the bicycles were provided by employees of SRAM, and two were provided by employees of Shimano, neither of whom had knowledge of the testing to be performed. The client requested that the bikes exhibit a mix of the most common types of racing bicycles and their accompanying drivetrains. This includes both mechanical and electronic drivetrains from major manufacturers Shimano and SRAM. The different drivetrain types were selected to investigate any interference between the electronic drivetrains and the UCI Scanner. The bikes are listed below, and shown in Figures 3 through 6.

- Focus Cayo carbon, size small, SRAM Rival mechanical drivetrain
- Cannondale Supersix Evo carbon, 48cm, SRAM Red Etap electronic drivetrain
- Cannondale Supersix Evo carbon, 56cm, Shimano Dura-ace mechanical drivetrain
- Trek Emonda SL carbon, 50cm, Shimano Ultegra Di2 electronic drivetrain

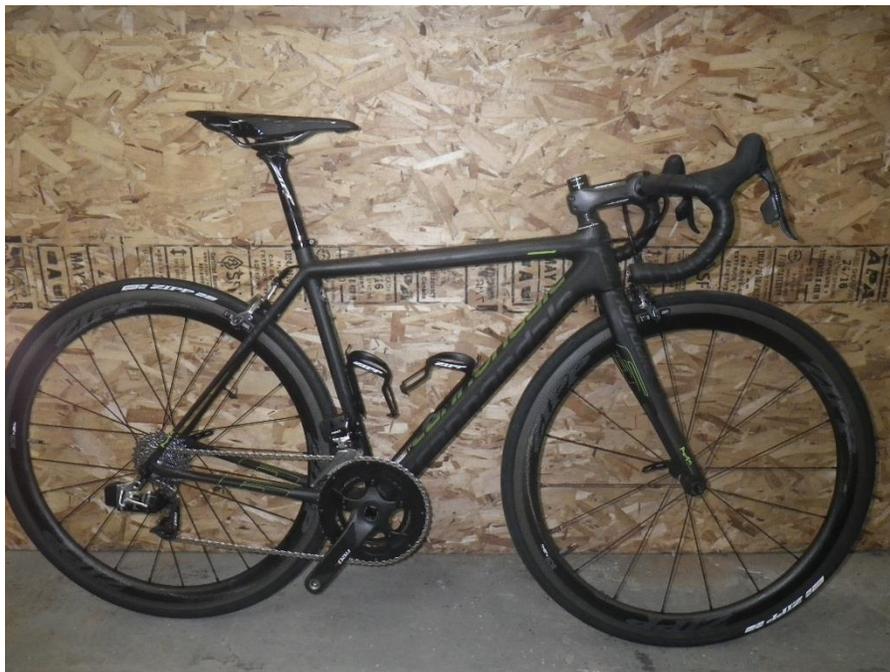
Figure 4: Cannondale Supersix Evo carbon, 48cm, SRAM Red Etap electronic drivetrain.

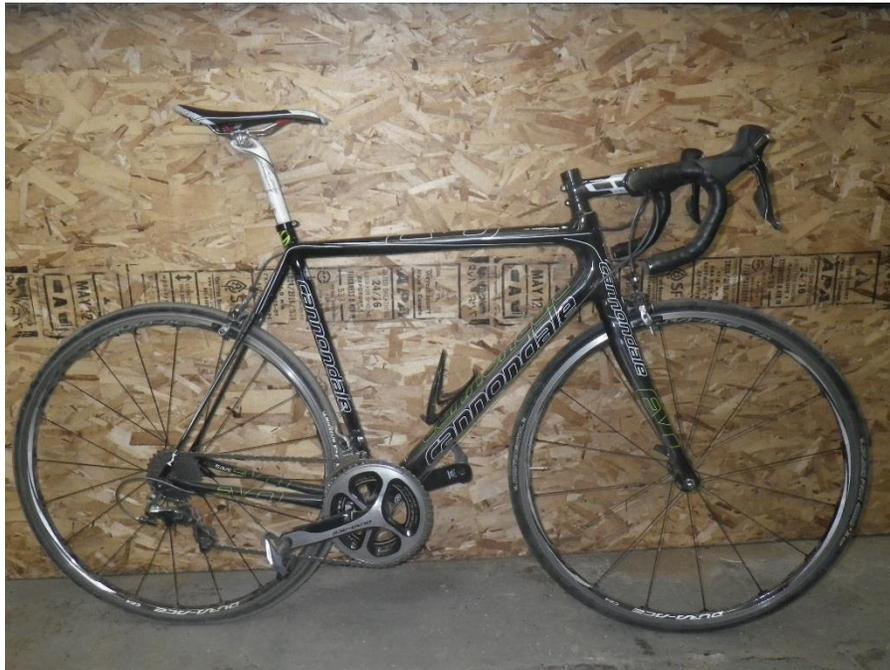
Figure 5: Cannondale Supersix Evo carbon, 56cm, Shimano Dura-ace mechanical drivetrain.

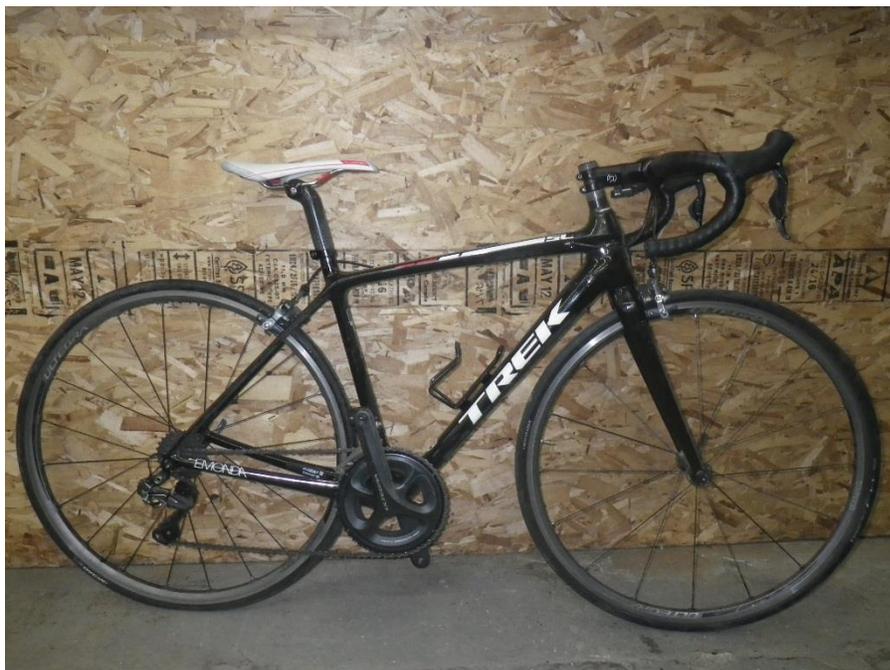
Figure 6: Trek Emonda SL carbon, 50cm, Shimano Ultegra Di2 electronic drivetrain.

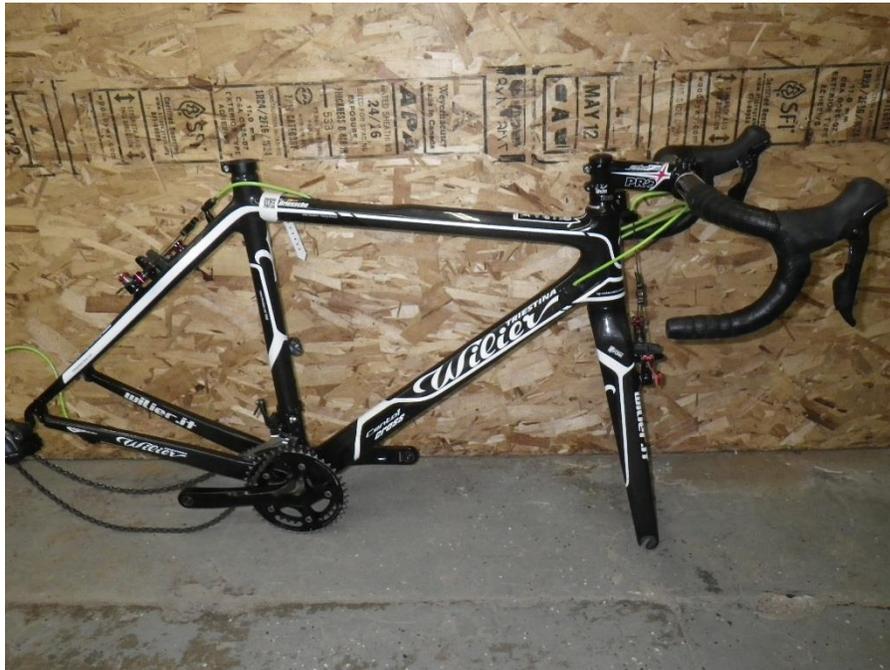
Figure 7: Wilier Cento1 Cross carbon cyclocross frame and fork, with known, bicycle specific motor contained in the seat-tube.

One (1) additional bicycle frame, fork, and drivetrain was provided by the client for testing. This frameset was a Wilier Cento1 Cross carbon cyclocross frame and fork, and is shown in Figure 7. This frameset had a known bicycle-specific motor installed into the seat-tube.

The testing also included the fifth carbon fiber bicycle frame, the Wilier Cento1 Cross frame, which contained a known motor, and was used as a control in the study. This frame was not tested in replicate, but did also incorporate the stepped 10mm Scanner distance increments. The operator did know a motor was present in this frame, and was not a part of the blind testing.

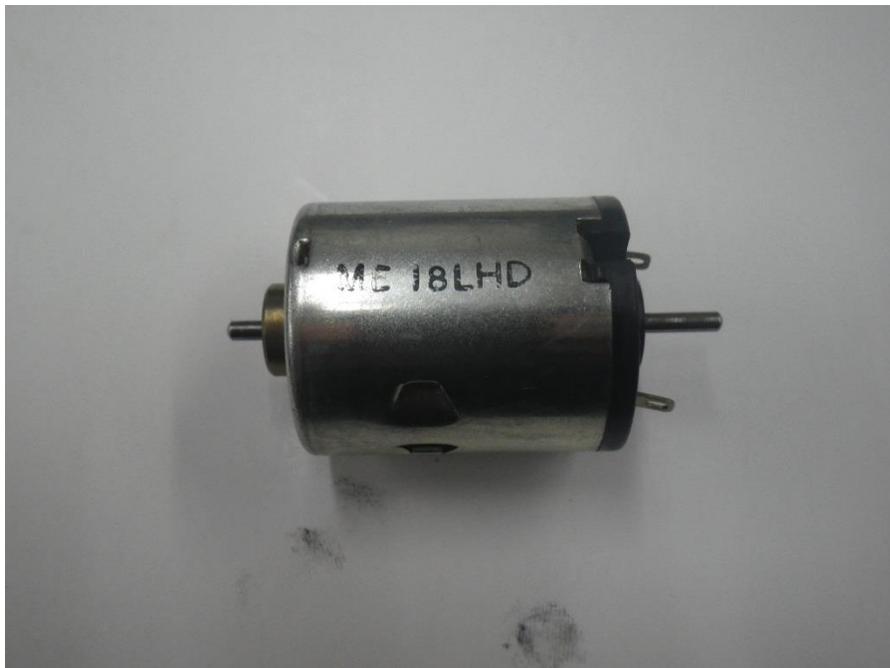
Figure 8: Micromo series M3138U DC micromotor with 6V windings and output power of 19.65 watts.

Microbac attempted to acquire motors designed for drive assistance at the crank spindle and intended to be placed in the seat tube, but was unsuccessful. A motor of comparable physical size was selected for validation of the scanning equipment. Physical size was prioritized so the motor could be hidden in a frame, and a blind test be executed by Microbac staff, without knowledge of the motor's location. The motor selected for testing was a Micromo series M3138U DC micromotor with 6V windings and output power of 19.65 watts. It should be noted that typical crank-spindle mounted assistance motors can reportedly produce 250 or more watts of power, and therefore the Micromo motor would theoretically be more difficult for the Scanner to detect because of its lower power output and fewer windings. The motor used in testing herein is shown in Figure 8.
